Incorrect valve body calibration, missing B5 control spring

B5 Control Spring

59947-33

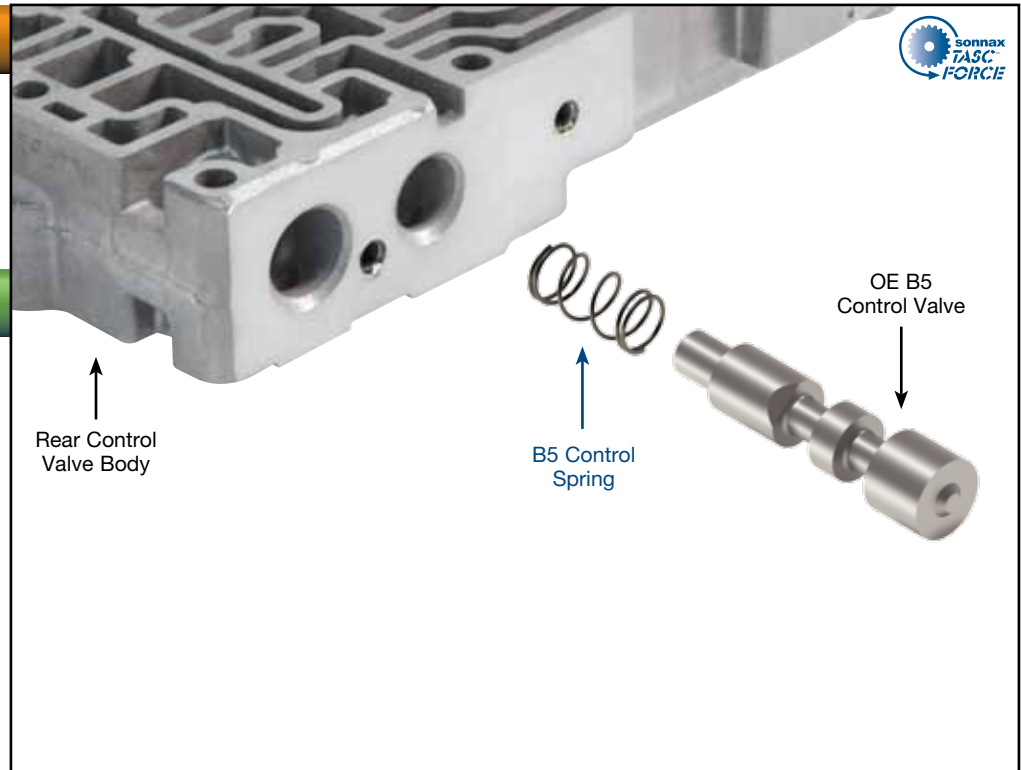
TCM programming anticipates spring control response in the B5 control line-up in certain vehicles. Without this spring, the calibration is mismatched and 2-3/3-2 shift issues may occur.

Only some '05-later units were equipped with a control spring in the B5 clutch control valve line-up.

Only some Aisin AW 55-50SN transmissions ('05-later units installed in Nissan and GM vehicles) were equipped with a control spring in the B5 clutch control valve line-up. Using a valve body without a spring in those vehicles creates a mismatch between the B5 line-up and the TCM calibration, often causing a harsh 2-3 upshift or 3-2 downshift. Sonnax offers B5 control spring **59947-33** as a direct replacement for the OE spring. This allows rebuilders to rebuild any suitable core for use in vehicles where the spring is required, or correct shift concerns caused by a missing spring.

The Sonnax B5 control spring is a direct replacement for the OE spring and it can be added to any valve body in order to match the TCM calibration.
